**GEOTECHNICAL INVESTIGATION FOR
PROPOSED APARTMENT BUILDING**

Sylvan Avenue Property

500 Sylvan Avenue

GeoForensics, Inc.

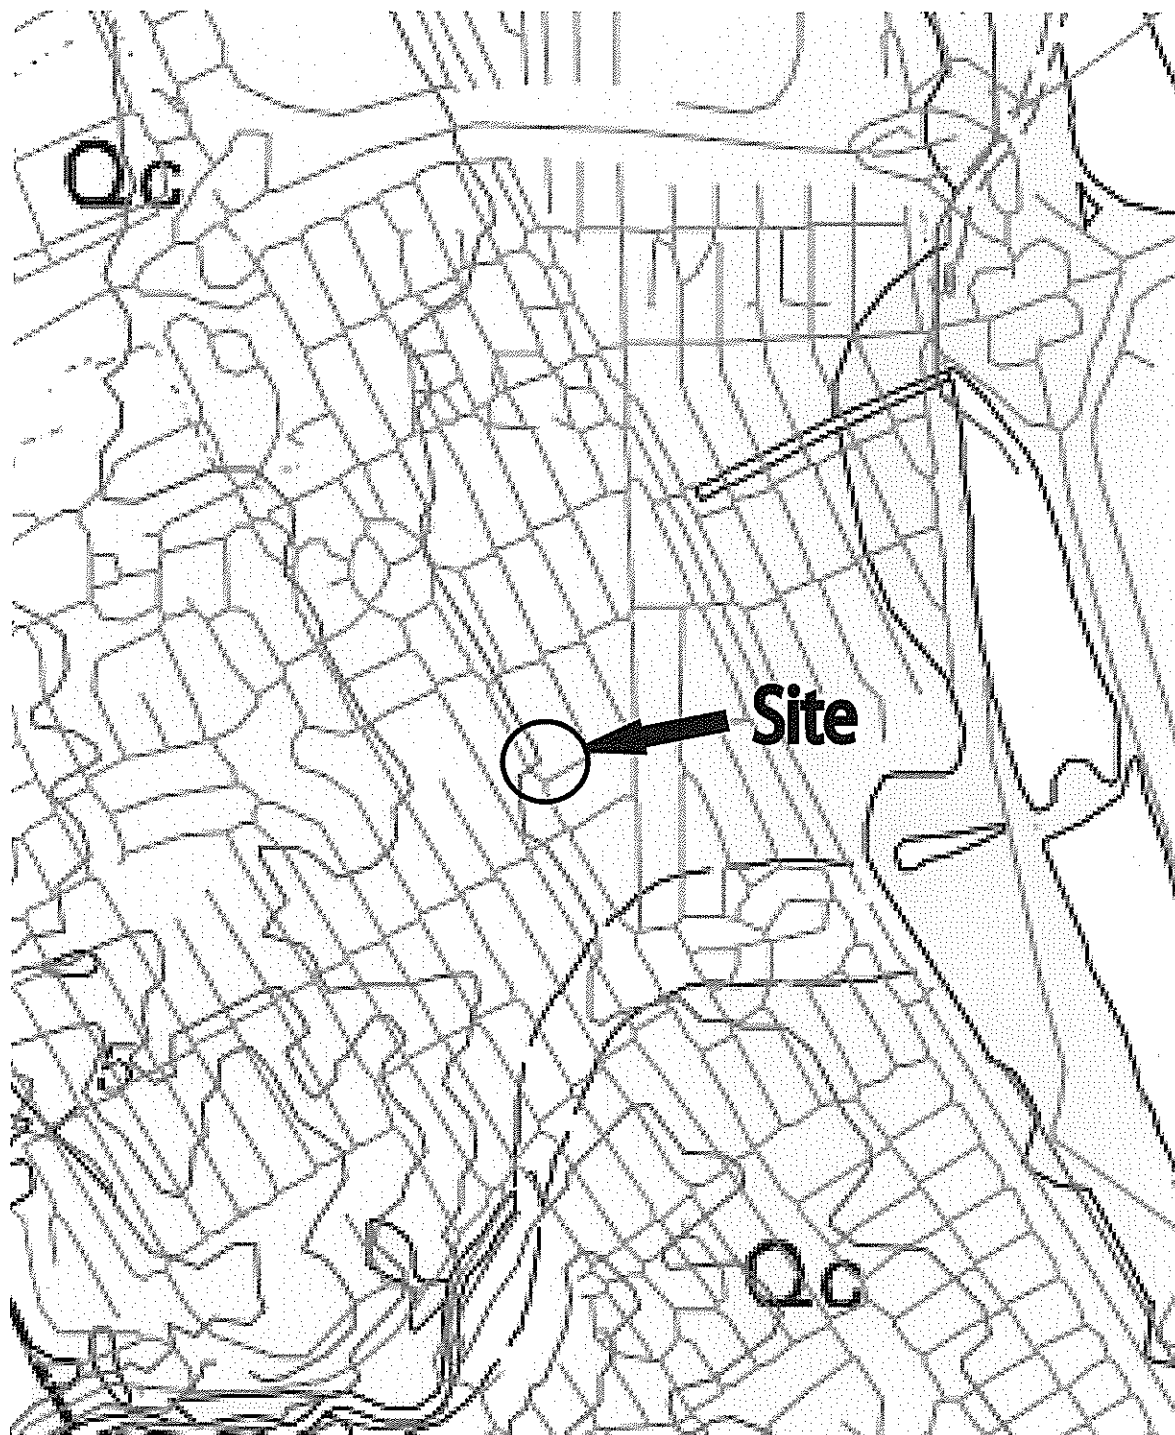
Figure 3 - Gelogic Map

Qc

Colma Formation (Pleistocene)—Yellowish-gray and gray to yellowish-orange and red-brown, friable to loose, fine-to medium-grained arkosic sand with subordinate amounts of gravel, silt, and clay. Total thickness unknown, but may be as great as 60 m

We reviewed the *Geology of the Onshore Part of San Mateo County, California: Derived from the Digital Database Open-File 98-137*, by Earl E. Brabb, R.W. Graymer, and D.L. Jones (1998). The relevant portion of the Brabb, Graymer, and Jones map has been reproduced in Figure 3.

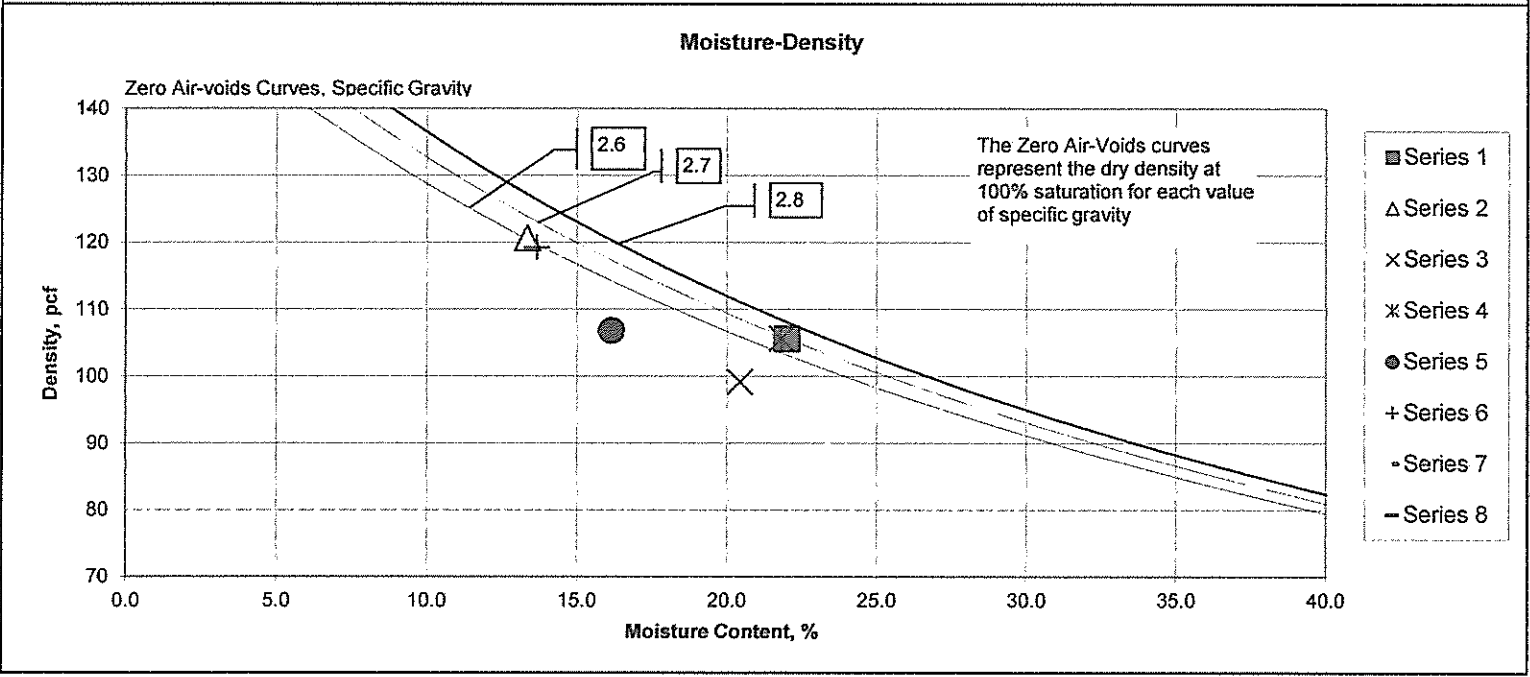
Moisture-Density-Porosity Report

Actual G_s								
Assumed G_s	2.70	2.70	2.70	2.70	2.70	2.70		
Moisture, %	22.0	13.3	20.4	21.8	16.2	13.7		
Wet Unit wt, pcf	128.8	136.8	119.4	128.7	124.1	135.5		
Dry Unit wt, pcf	105.5	120.7	99.2	105.7	106.8	119.2		
Dry Bulk Dens. pb, (g/cc)	1.69	1.93	1.59	1.69	1.71	1.91		
Saturation, %	99.3	90.5	78.7	98.8	75.3	88.9		
Total Porosity, %	37.4	28.5	41.2	37.4	36.7	29.3		
Volumetric Water Cont., θ_w , %	37.2	25.8	32.4	36.9	27.6	26.1		
Volumetric Air Cont., θ_a , %	0.3	2.7	8.8	0.4	9.1	3.3		
Void Ratio	0.60	0.40	0.70	0.60	0.58	0.41		
Series	1	2	3	4	5	6	7	8

Note: All reported parameters are from the as-received sample condition unless otherwise noted. If an assumed specific gravity (G_s) was used then the saturation, porosities, and void ratio should be considered approximate.

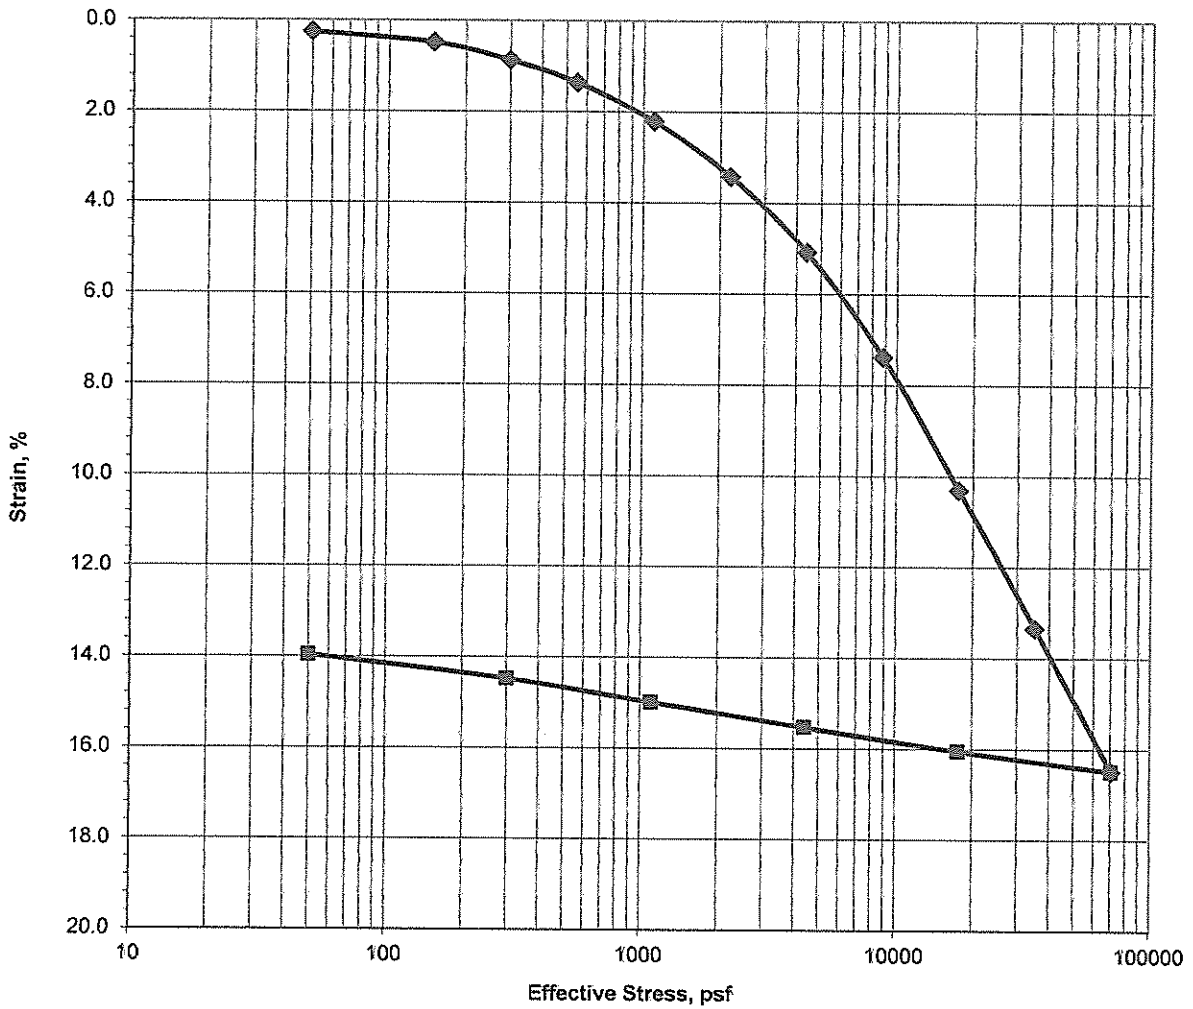
Strain-Log-P Curve

Consolidation Test

Job No.: 060-2557	Boring: 1-1	Run By: MD
Client: GeoForensics	Sample:	Reduced: PJ
Project: Sylvan - 217179	Depth, ft.: 4	Checked: PJ/DC
Soil Type: Black Clayey SAND		Date: 8/3/2017

Assumed Gs	2.65			Remarks:
Moisture %:	22.6	16.9		
Dry Density, pcf:	97.2	114.3		
Void Ratio:	0.702	0.448		
% Saturation:	85.4	100.0
